# Comprehensive Assessment of Cycle Tracks in Pune

November 2011

Study supported by  
Centre for Policy Research, Delhi

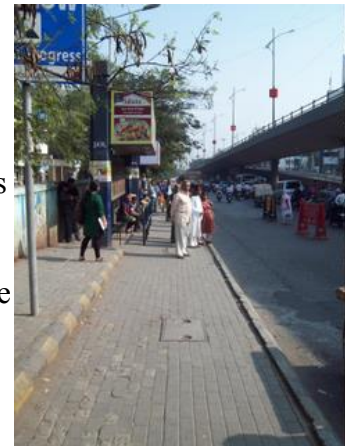
This is a type of cycle track where the track is level segregated from the carriage way (at a height >10inches, from the carriage-way) and also level segregated from the footpath (4-6inches of height difference). It has been observed that all the tracks of this design have the track surface built with interlocking blocks. The increased height of the cycle tracks from the carriage-way pose a hazard for the cyclist. If the cyclist is on the right side of the track and is forced to stop, the cyclist will have to step on to the carriage-way, which would be >10inches below the cycle track surface.

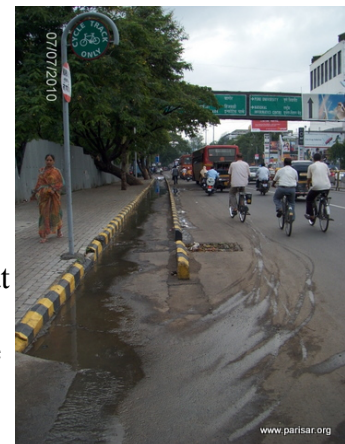
##### Same level as carriage-way

These are tracks which are the same level as the road surface. The tracks of this type maybe separated with curbstones. These are the most practical tracks to have in the city, they not only reduce the cost of building/or just marking a cycle track but also they are not as hazardous as those which are at >10inch height from the carriage-way. Satara Road and Solapur road are tracks that are of this design. These tracks are part of the Pilot BRT project of Pune. The main advantage of tracks that are at the same level as the carriage-way is that they are built either with concrete or asphalt. These material types provide a better cycling surface when compared to interlocking blocks.

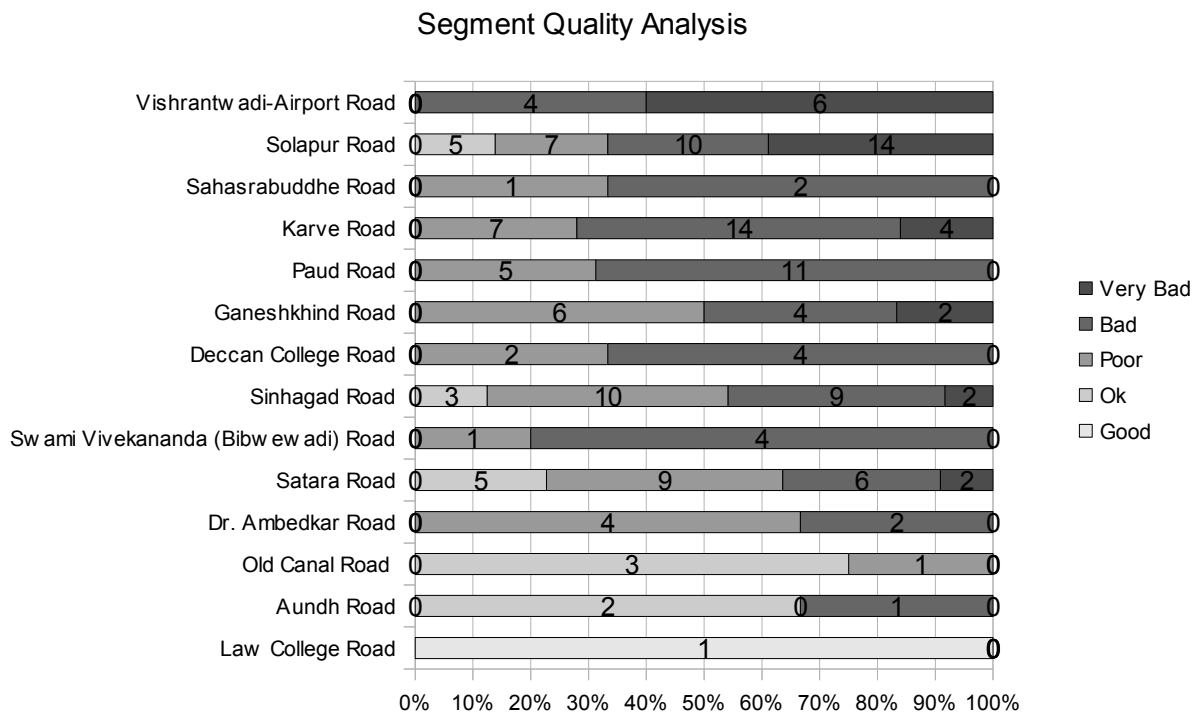
It is observed that within one road different segments can have varying quality. This can be seen in the chart below.

- Law College road has a single segment which is 'Good'. It is the only cycle track to have a 'Good' rated segment.<sup>6</sup>
- Vishrantwadi-Airport road has only 'Bad' and 'Very Bad' segments
- Solapur road, Satara road and Sinhagad road all have a mix of segments that vary from 'Ok' to 'Very Bad'
- All other roads have a mix of 'Poor', 'Bad' and some 'Very Bad' segments.

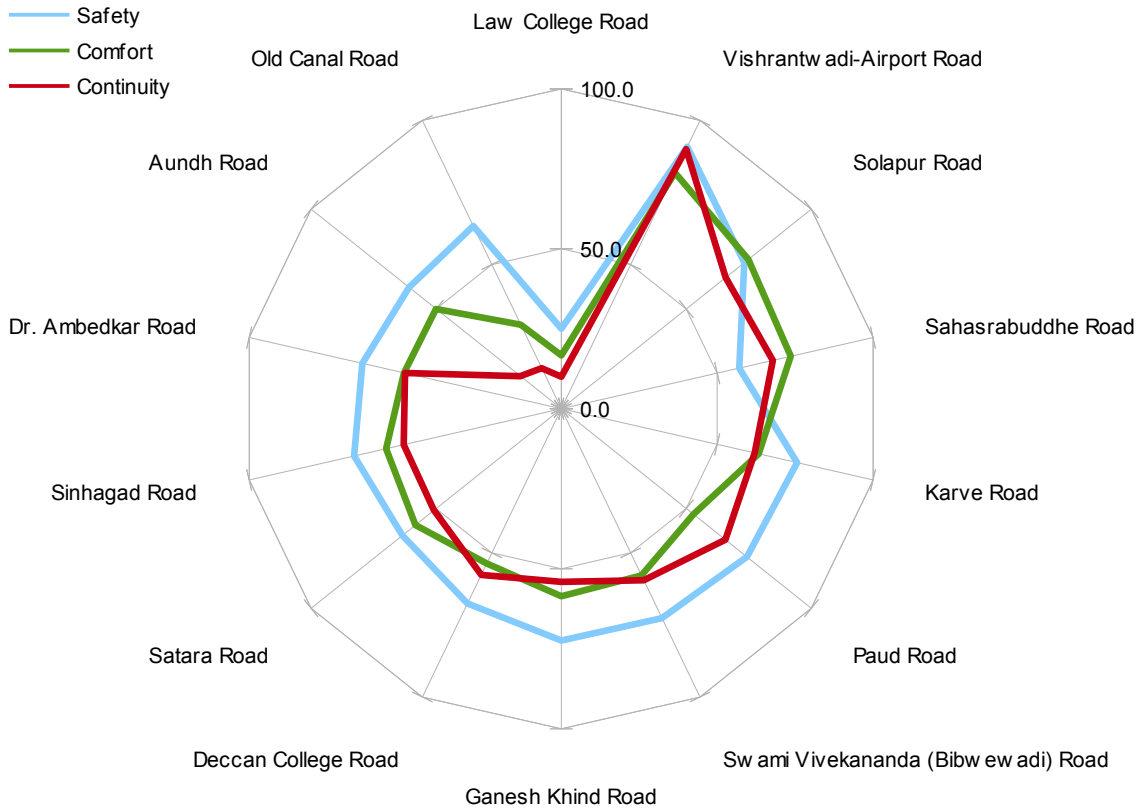
### 4.3 Safety, Comfort and Continuity

- Generally one sees that all cycle tracks fare the worst with regards to safety (higher scores), except for Sahasrabuddhe road
- Comfort and Continuity more or less lie in the same narrow band except for the two best and two worst cycle tracks
- Continuity of Law College road (which is anyway a very small stretch) and Old Canal road cycle tracks are better
- Amongst the middle rated cycle tracks, Comfort rating of Paud road cycle track is slightly better

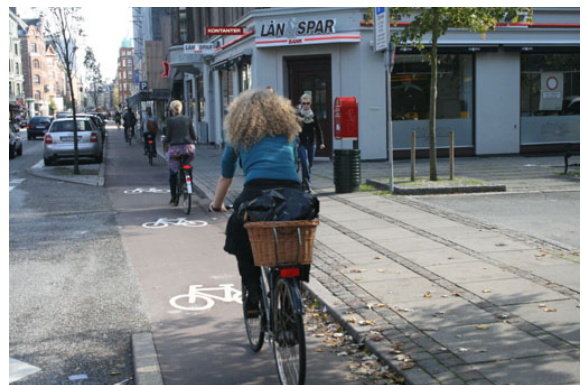
Illustration 3: Where cycle tracks are not segregated they can still be well marked so as to maintain visual continuity for cyclists.

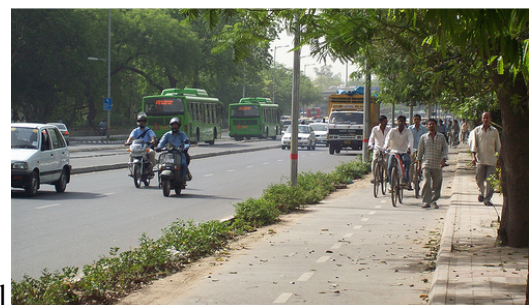
Illustration 4: Well designed cycle tracks along the Delhi BRT corridor are free from obstructions and have a smooth riding surface.

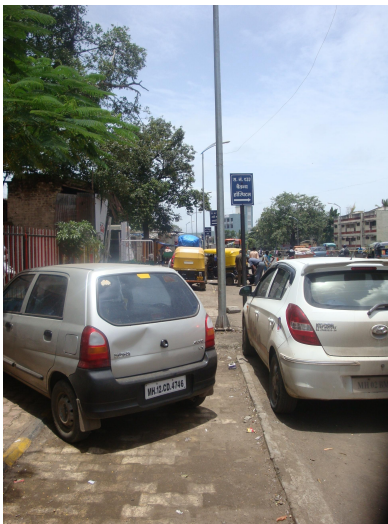
Picture3.5.1: Vehicles parked on Cycle Track

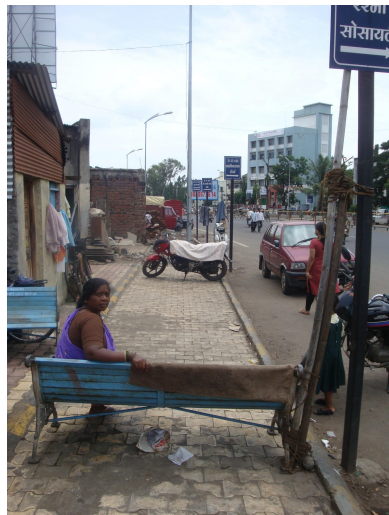
Picture3.5.2: People sitting on Cycle Track

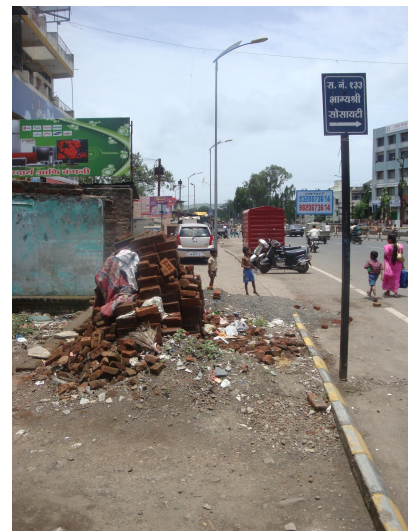
Picture 3.5.3: Construction material on Cycle Track

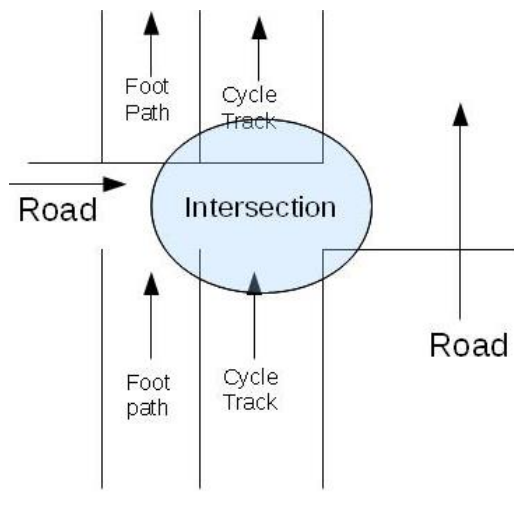
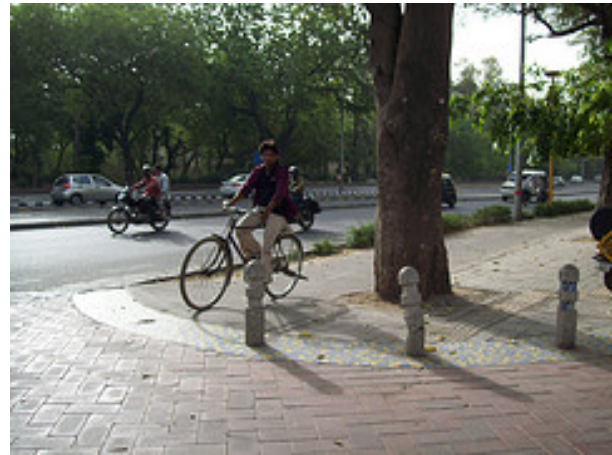
*Illustration 5: Raised crossings and different materials enhance the safety of cyclists at intersections.*

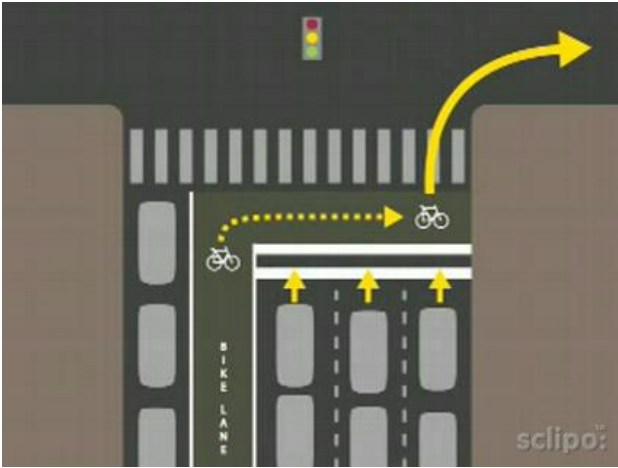
*Illustration 6: A bike box is used at intersections to designate a space for cyclists to wait in front of other vehicles at a red light, and to proceed first when the light turns green.*

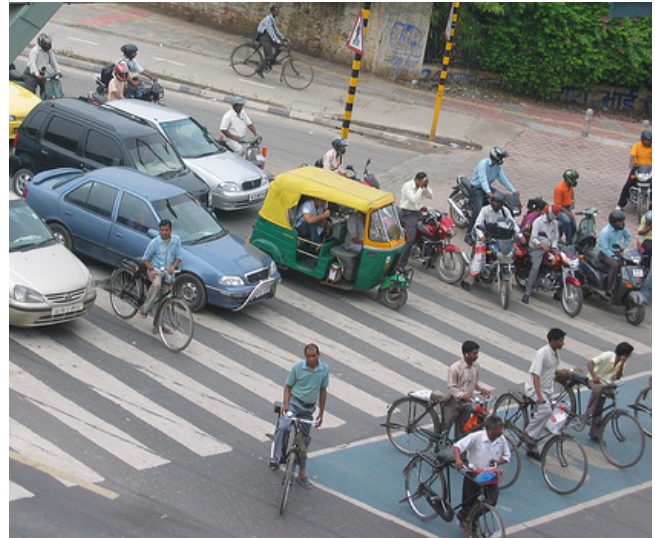
*Illustration 7: Use of a bike box for cyclists turning right or going straight in Delhi*
