SAFE PEDESTRIAN CROSSING

@ GANESHKIND ROAD

Aditya Chawande
Architect Urban Designer
Project Associate, **Parisar**

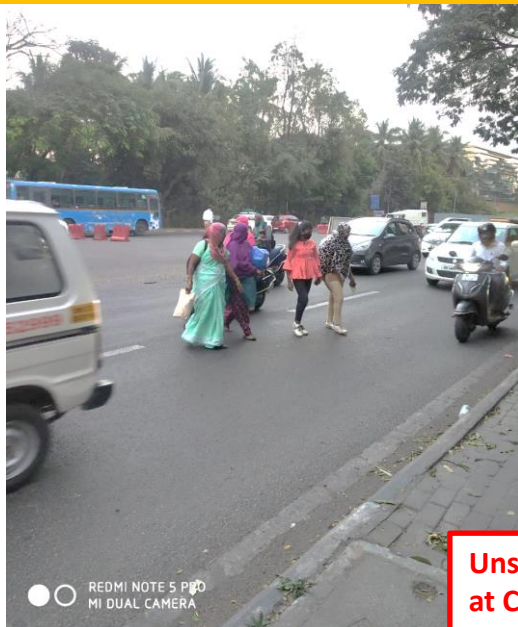
Unsafe Road Opening at Cosmos Bank

- No safe pedestrian crossing in 1.30km stretch.
- Higher detour length

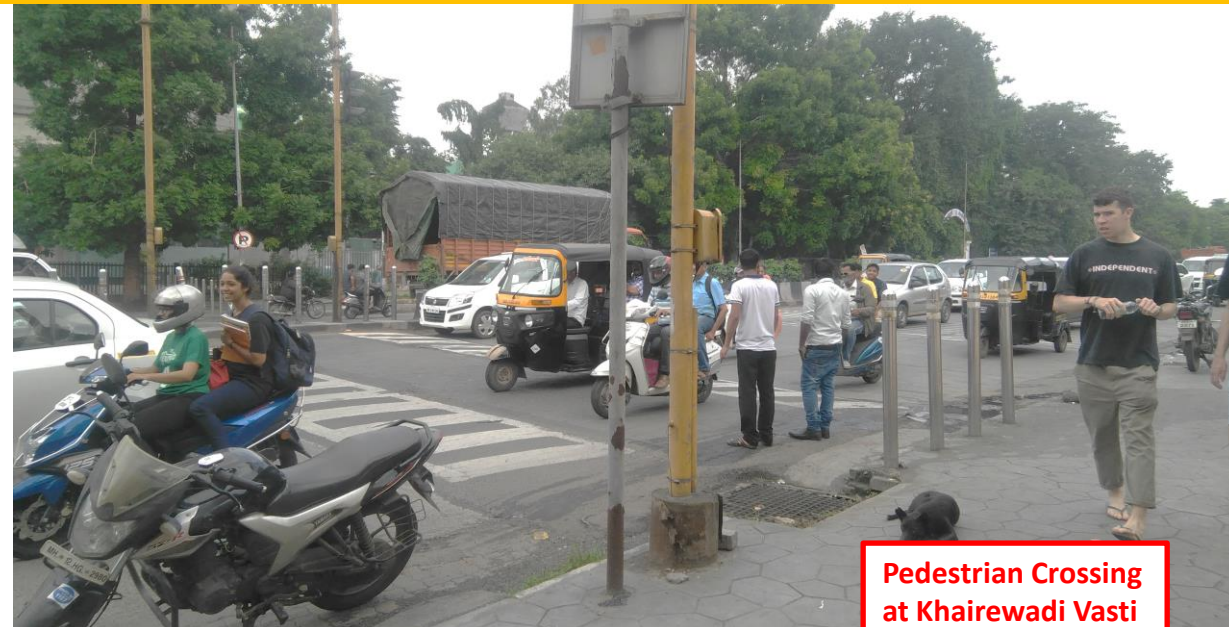
Pedestrian Crossing at Khairwadi Vasti

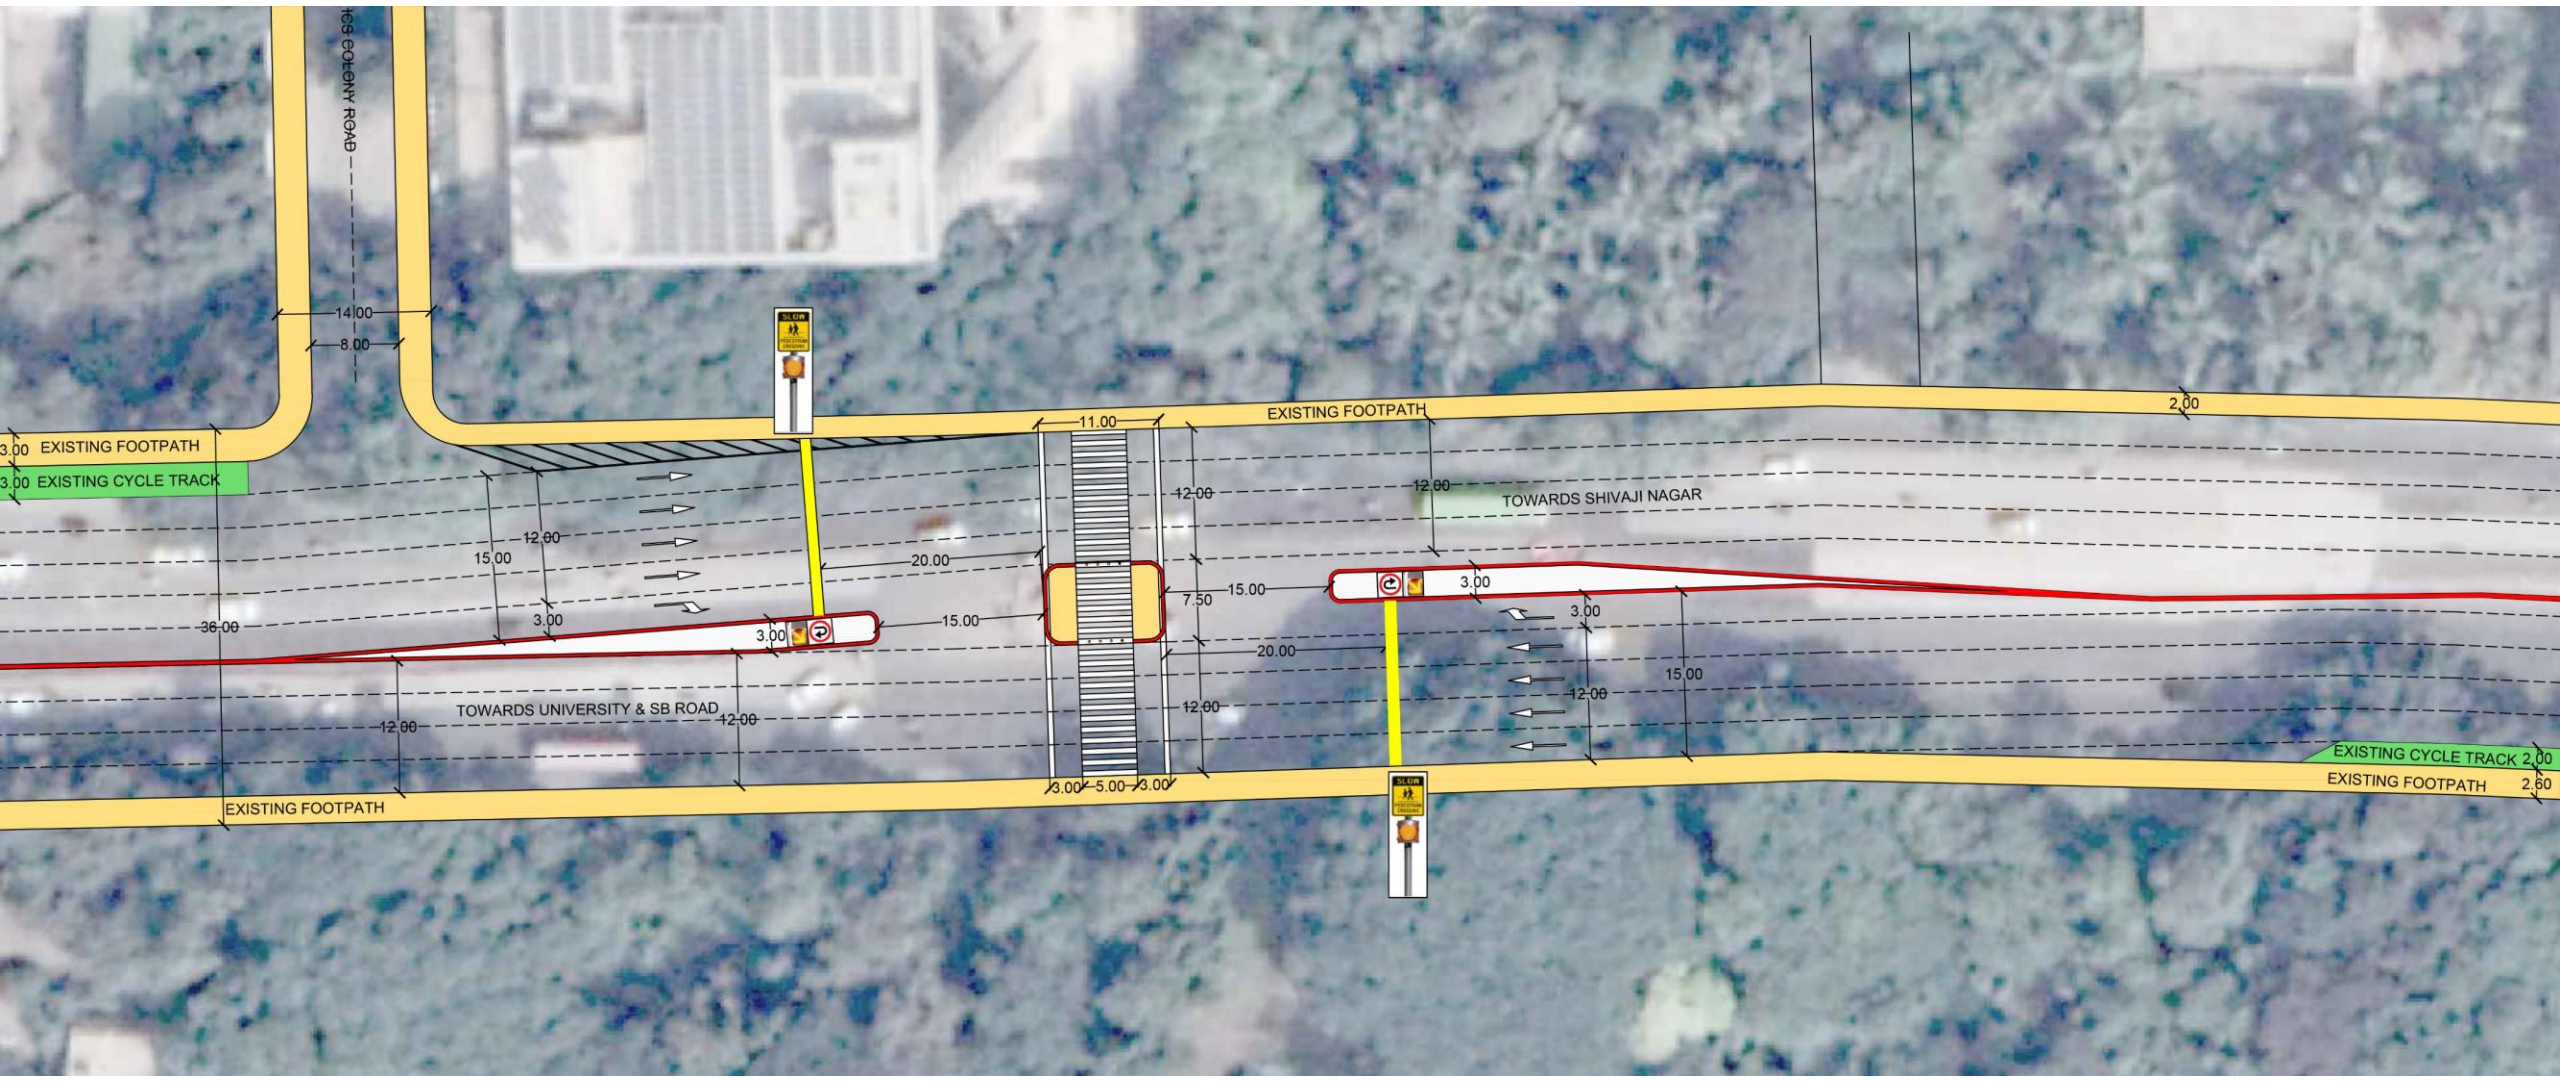
Proposed Tactical Intervention- @ Cosmos Bank, Ganeshkhind Road
